**Flood Control Project Maintenance  
Levee Inspections**  
**LMA District Cover Sheet**  
**Spring 2019 Levee Inspection Results**

**Reclamation District No. 0003 Grand Island**

**Spring 2019 Levee Inspection Results**

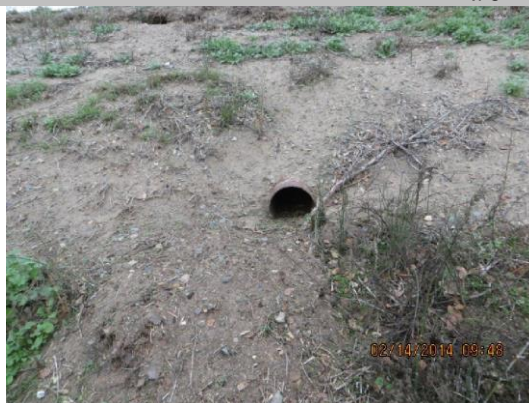
Photo 1 of 2 : UCIP\_SP\_2019\_41583\_55234.jpg

LM Start	0.06	Rating **	M	Issue No.	189
LM End	0.06	Issue Type +	En	Location *	
Category	Supplemental			GPS Latitude/Longitude	
				Start	End
Item	DWR UCIP Field Study			38.303892 °	38.303892 °
				-121.575309 °	-121.575309 °
DWR ID	22134				
Comment Code					
Inspector Comment					
FS_ID:41583 DS_ID:22134 EP_NO: N/A Repair Type: Non-Urgent Crossing Status: Found UCIP Comments: Pipe open on LS slope. Appears abandoned and if so should be done so properly. FIELD_STRUCT_DESC: *ABANDONED* 10-inch steel irrigation pipe through the levee, invert elevation 6.6 feet below the crown. 36-inch concrete standpipe visible 30 feet upstream from the crossing on the landside (LS) toe. Pipe open on both ends. [Additional Reference(s): DWR Levee Log, 1993. USACE Sacramento O&M Manual 104, February 1960, (RM 26.06)]. FS Date: 8/27/2014

Open pipe visible on LS slope.

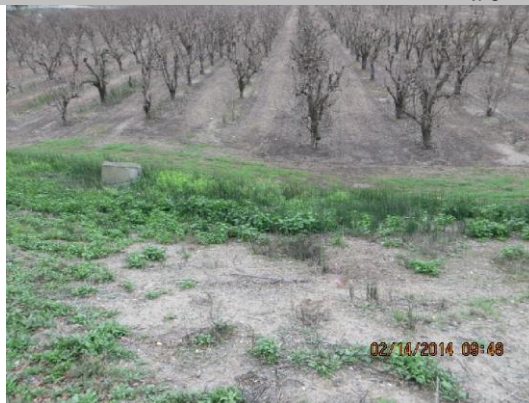
Photo 2 of 2 : UCIP\_SP\_2019\_41583\_55233.jpg

LM Start	0.06	Rating **	M	Issue No.	189 (cont)	
LM End	0.06	Issue Type +	En	Location *		
Category	Supplemental			GPS Latitude/Longitude		
				Start		End
Item	DWR UCIP Field Study			38.303892 °	38.303892 °	
				-121.575309 °	-121.575309 °	
DWR ID	22134					
Comment Code						
Inspector Comment						
FS_ID:41583 DS_ID:22134 EP_NO: N/A Repair Type: Non-Urgent Crossing Status: Found UCIP Comments: Pipe open on LS slope. Appears abandoned and if so should be done so properly. FIELD_STRUCT_DESC: *ABANDONED* 10-inch steel irrigation pipe through the levee, invert elevation 6.6 feet below the crown. 36-inch concrete standpipe visible 30 feet upstream from the crossing on the landside (LS) toe. Pipe open on both ends. [Additional Reference(s): DWR Levee Log, 1993. USACE Sacramento O&M Manual 104, February 1960, (RM 26.06)]. FS Date: 8/27/2014

Concrete standpipe visible on LS slope

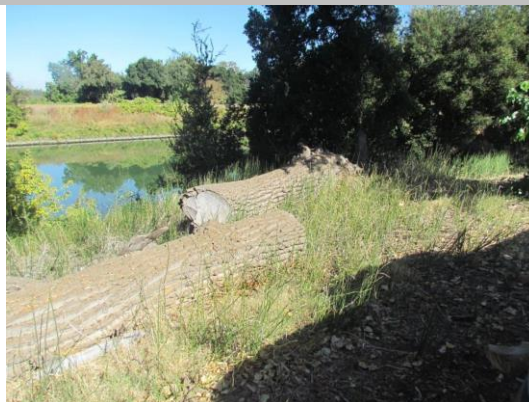
Photo 1 of 2 : SP\_2019\_RD0003\_24\_19\_20190311\_00017.jpg

LM Start	0.13	Rating **	M	Issue No.	19
LM End	0.13	Issue Type +	Ma	Location *	WS
Category	Earthen Levee			GPS Latitude/Longitude	
				Start	End
Item	Encroachments			38.303305 °	38.303305 °
				-121.576537 °	-121.576537 °
DWR ID	DWR_RD0003_01_f_2012_19				
Comment Code					
TR : Tree or limb					
Inspector Comment					
Tree branches and limbs are located on waterward shoulder.

Looking north at tree branches on waterward slope. (Fall 2016)

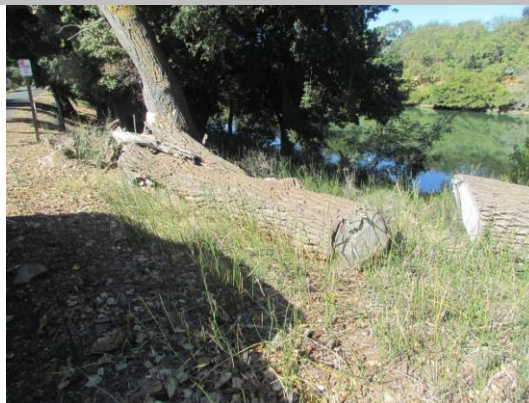
Photo 2 of 2 : SP\_2019\_RD0003\_24\_19\_20190311\_00018.jpg

LM Start	0.13	Rating **	M	Issue No.	19 (cont)	
LM End	0.13	Issue Type +	Ma	Location *	WS	
Category	Earthen Levee			GPS Latitude/Longitude		
				Start	End	
Item	Encroachments			38.303305 °	38.303305 °	
				-121.576537 °	-121.576537 °	
DWR ID	DWR_RD0003_01_f_2012_19					
Comment Code						
TR : Tree or limb						
Inspector Comment						
Tree branches and limbs are located on waterward shoulder.

Looking west at tree branch on waterward shoulder and slope. (Fall 2016)

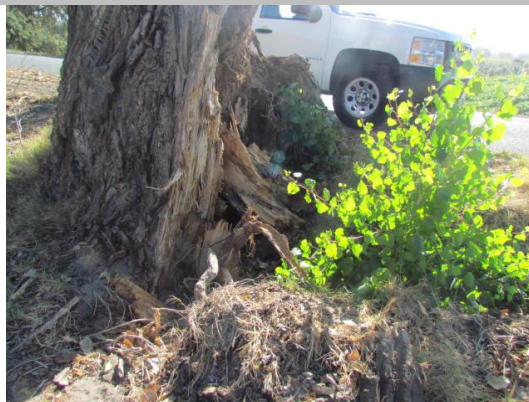
Photo 2 of 3 : SP\_2019\_RD0003\_24\_2\_20190311\_00002.jpg

Looking at a hole next to oak tree on waterward shoulder. (2015)

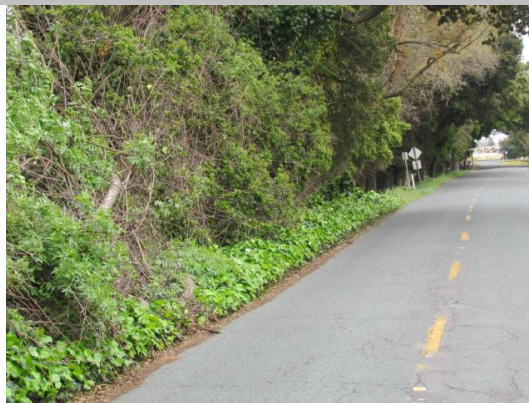
Photo 1 of 2 : SP\_2019\_RD0003\_24\_6\_20190311\_00004.jpg

LM Start	0.22	Rating **	U	Issue No.	6
LM End	0.33	Issue Type +	En	Location *	WS
Category	Earthen Levee			GPS Latitude/Longitude	
				Start	End
Item	Vegetation			38.302530 °	38.301424 °
				-121.577848 °	-121.579113 °
DWR ID	DWR_RD0003_01_s_2012_6				
Comment Code					
V6 : Landscaping					
Inspector Comment					
There is dense landscaping on waterward shoulder and slope.

Looking northeast at dense landscaping on waterward shoulder.

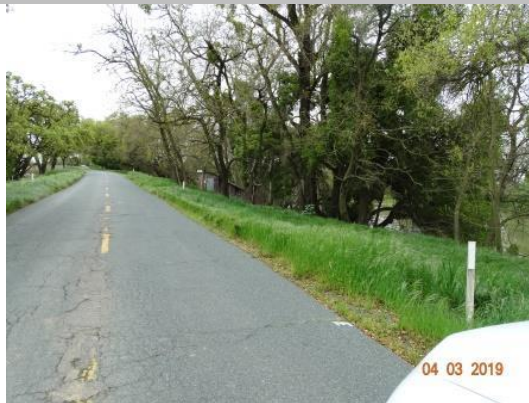
Photo 1 of 1 : SP\_2019\_RD0003\_24\_88\_20190403\_00168.jpg

LM Start	0.52	Rating **	M	Issue No.	88
LM End	4.41	Issue Type +	Ma	Location *	WS
Category	Earthen Levee			GPS Latitude/Longitude	
				Start	End
Item	Vegetation			38.298852 °	38.252558 °
				-121.580501 °	-121.600832 °
DWR ID	DWR_RD0003_01_s_2019_88				
Comment Code					
V1 : Control annual grass and weeds on the levee slopes and easements.					
Inspector Comment					
Maintain annual vegetation.

View looking downstream at annual vegetation on the waterside slope  
(Spring 2019).

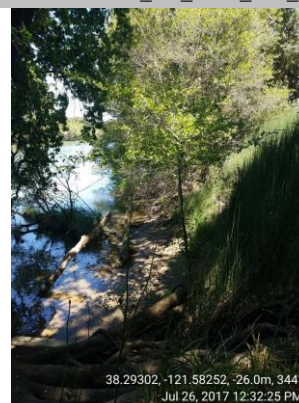
Photo 1 of 3 : LEVAL\_SP\_2019\_275\_2396.jpg

LM Start	0.91	Rating **	A/W	Issue No.	53
LM End	0.97	Issue Type +	Ma	Location *	WS
Category	Supplemental			GPS Latitude/Longitude	
				Start	End
Item	2017 Storm Damage			38.293381 °	38.292617 °
				-121.582450 °	-121.582675 °
DWR ID	DWR_RD0003_01_s_2018_53				
Comment Code					
Inspector Comment					
Levee Evaluation Comments					
Description:District station 48+20 to 51+06, Sec. 07, T. 5 N. R. 4 E., M.D.M. An erosion site exists along approximately 286 linear feet of the waterside slope of Steamboat Slough (Unit 1). The erosion begins approximately 1/2 of the way down the slope from the crown to the waterside toe. Erosion is undercutting existing trees.					
Site ID No:275					
Site Designation:LMA-101					
Repair Type: Erosion					
Rating:Serious					
Field Date:7/26/2017					
Notes:

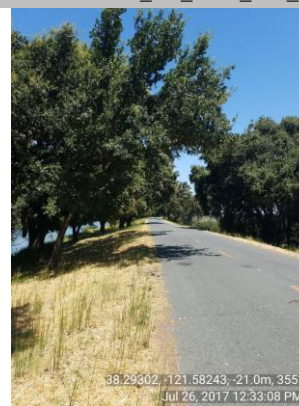
Photo 3 of 3 : LEVAL\_SP\_2019\_275\_2399.jpg

LM Start	0.91	Rating **	A/W	Issue No.	53 (cont)
LM End	0.97	Issue Type +	Ma	Location *	WS
Category	Supplemental			GPS Latitude/Longitude	
				Start	End
Item	2017 Storm Damage			38.293381 °	38.292617 °
				-121.582450 °	-121.582675 °
DWR ID	DWR_RD0003_01_s_2018_53				
Comment Code					
Inspector Comment					
Levee Evaluation Comments					
Description: District station 48+20 to 51+06, Sec. 07, T. 5 N. R. 4 E., M.D.M. An erosion site exists along approximately 286 linear feet of the waterside slope of Steamboat Slough (Unit 1). The erosion begins approximately 1/2 of the way down the slope from the crown to the waterside toe. Erosion is undercutting existing trees.					
Site ID No: 275					
Site Designation: LMA-101					
Repair Type: Erosion					
Rating: Serious					
Field Date: 7/26/2017					
Notes:

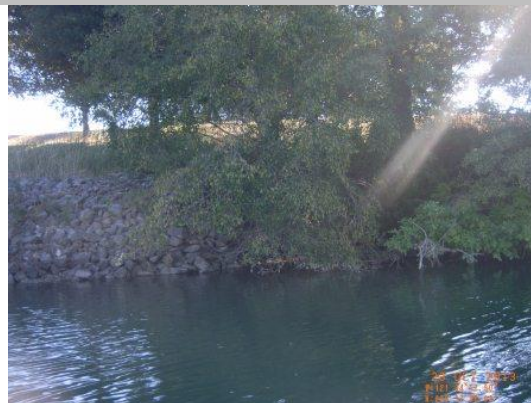
Photo 1 of 1 : SP\_2019\_RD0003\_24\_49\_20190311\_00030.jpg

Comment Code					
Inspector Comment					
2017 Site ID: STM 25.0 L					
Status: Critical					
2018: Deep erosion into levee toe. Roots are exposed. I would consider this critical.					
2017 Field Notes: Upgraded to critical. Site has eroded to near vertical at upstream end.					
Site History: 1997 - Erosion of sandy levee on top left bank. Site is downstream of a rock section. Large riparian trees on the bank. 1999 - Upstream half of the reach repaired with rock, except for a 30 ft reach at the upstream end. 2001 - Rock repair on the upstream and downstream ends; no revetment at the trees. 2002 - Rock repair is starting to slide off the geotextile at the upstream end. 2005 - One new small tree has fallen. 2006 - 50 ft pocket at the downstream end and at the upstream end with new rock in between. 2007 - Upstream end has been repaired. 2008 - Area closed sign on bank. Newly fallen trees at both ends and pop outs along the bank. 2010 - Site extended downstream. 2011 - New erosion at the toe. More trees popouts. 2013 - Short vertical sections observed at the downstream end. 2015 - Significant new erosion, large oak tree on verge of popping out. 2016 - Sites 24.8 and 25 were combined.

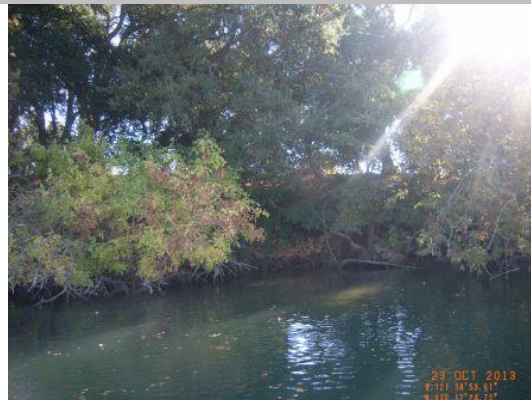
Photo 1 of 2 : SP\_2019\_RD0003\_24\_56\_20190311\_00041.jpg

LM Start	1.03	Rating **	U	Issue No.	56
LM End	1.18	Issue Type +	Ma	Location *	WS
Category	Supplemental			GPS Latitude/Longitude	
				Start	End
Item	2017 USACE Erosion Survey, DRAFT			38.291695 °	38.289575 °
				-121.582993 °	-121.583092 °
DWR ID	DWR_RD0003_01_f_2018_56				
Comment Code					
Inspector Comment					
2017 Site ID: STM 24.8 L Status: Eroding 2018: Pockets of erosion that are deep into the levee toe that I would consider critical (Djulian). 2017 Field Notes: New erosion at toe. Site History: 2008 - Area closed sign on bank. Newly fallen trees at both ends and pop outs along the bank. 2010 - Site extended downstream. 2011 - New erosion at the toe. More trees popouts. 2013 - Short vertical sections observed at the downstream end.

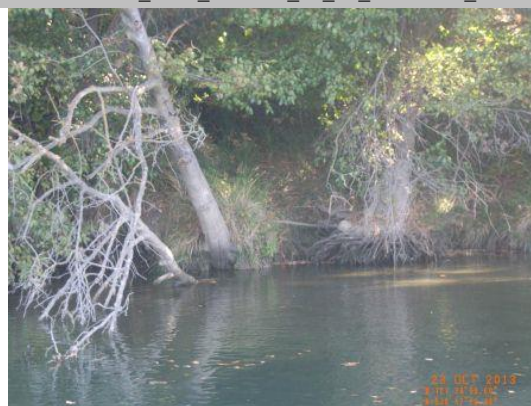
Photo 2 of 2 : SP\_2019\_RD0003\_24\_56\_20190311\_00042.jpg

LM Start	1.03	Rating **	U	Issue No.	56 (cont)	
LM End	1.18	Issue Type +	Ma	Location *	WS	
Category	Supplemental			GPS Latitude/Longitude		
				Start	End	
Item	2017 USACE Erosion Survey, DRAFT			38.291695 °	38.289575 °	
				-121.582993 °	-121.583092 °	
DWR ID	DWR_RD0003_01_f_2018_56					
Comment Code						
Inspector Comment						
2017 Site ID: STM 24.8 L						
Status: Eroding						
2018: Pockets of erosion that are deep into the levee toe that I would consider critical (Djulian).						
2017 Field Notes: New erosion at toe.						
Site History: 2008 - Area closed sign on bank. Newly fallen trees at both ends and pop outs along the bank. 2010 - Site extended downstream. 2011 - New erosion at the toe. More trees popouts.						
2013 - Short vertical sections observed at the downstream end.

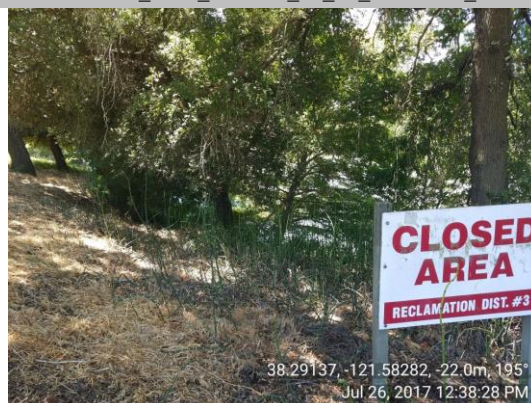
Photo 1 of 3 : SP\_2019\_RD0003\_24\_60\_20190311\_00046.jpg

LM Start	1.09	Rating **	A/W	Issue No.	60
LM End	1.10	Issue Type +	Ma	Location *	
Category	Supplemental			GPS Latitude/Longitude	
				Start	End
Item	2017 Storm Damage			38.290819 °	38.290706 °
				-121.582942 °	-121.582939 °
DWR ID	DWR_RD0003_01_f _ 2017_60				
Comment Code					
Inspector Comment					
Levee Evaluation Comments					
Description:District station 57+57 to 57+98, Sec. 18, 1. 5 N. R. 4 E., M.D.M. An erosion site exists along approximately 41 linear feet of the water side slope of Steamboat Slough (Unit 1). The erosion commences approximately 1/2 of the way down the slope from the crown to the waterside toe.					
Site ID No:276					
Site Designation:LMA-102					
Repair Type: Erosion					
Rating:Area of Concern					
Field Date:7/26/2017					
Notes:

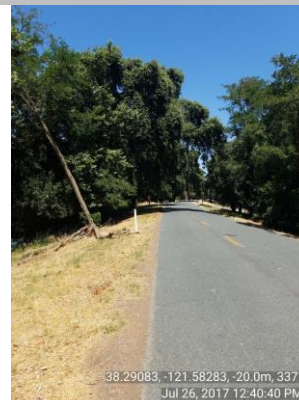
Photo 3 of 3 : SP\_2019\_RD0003\_24\_60\_20190311\_00048.jpg

LM Start	1.09	Rating **	A/W	Issue No.	60 (cont)	
LM End	1.10	Issue Type +	Ma	Location *		
Category	Supplemental			GPS Latitude/Longitude		
				Start	End	
Item	2017 Storm Damage			38.290819 °	38.290706 °	
				-121.582942 °	-121.582939 °	
DWR ID	DWR_RD0003_01_f _ 2017_60					
Comment Code						
Inspector Comment						
Levee Evaluation Comments						
Description:District station 57+57 to 57+98, Sec. 18, 1. 5 N. R. 4 E., M.D.M. An erosion site exists along approximately 41 linear feet of the water side slope of Steamboat Slough (Unit 1). The erosion commences approximately 1/2 of the way down the slope from the crown to the waterside toe.						
Site ID No:276						
Site Designation:LMA-102						
Repair Type: Erosion						
Rating:Area of Concern						
Field Date:7/26/2017						
Notes:

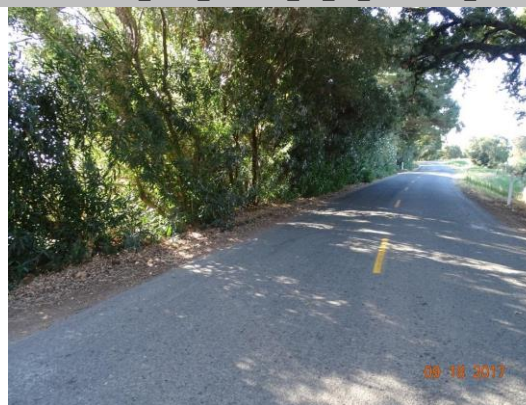
Photo 1 of 2 : SP\_2019\_RD0003\_24\_21\_20190311\_00020.jpg

LM Start	1.21	Rating **	U	Issue No.	21
LM End	1.26	Issue Type +	En	Location *	LS
Category	Earthen Levee			GPS Latitude/Longitude	
				Start	End
Item	Vegetation			38.289130 °	38.288327 °
				-121.582800 °	-121.582822 °
DWR ID	DWR_RD0003_01_s_2013_21				
Comment Code					
V6 : Landscaping					
Inspector Comment					
Landscaping has been in place for several years.

Looking south at landside slope.

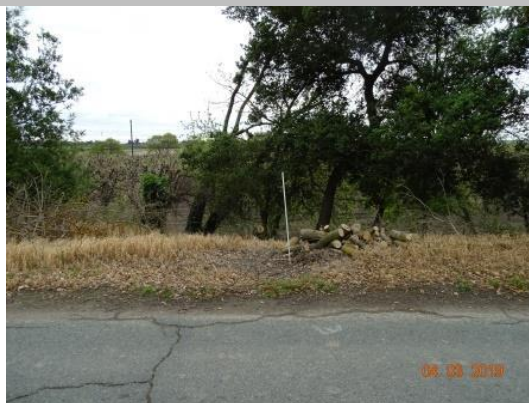
Photo 1 of 1 : SP\_2019\_RD0003\_24\_108\_20190403\_00170.jpg

LM Start	1.29	Rating **	M	Issue No.	108
LM End	1.29	Issue Type +	En	Location *	LS
Category	Earthen Levee			GPS Latitude/Longitude	
				Start	End
Item	Encroachments			38.287920 °	38.287920 °
				-121.582822 °	-121.582822 °
DWR ID	DWR_RD0003_01_s_2019_108				
Comment Code					
TR : Tree or limb					
Inspector Comment					
Remove trimmed tree branches from landside slope

View of trimmed tree branches on landside shoulder (Spring 2019).

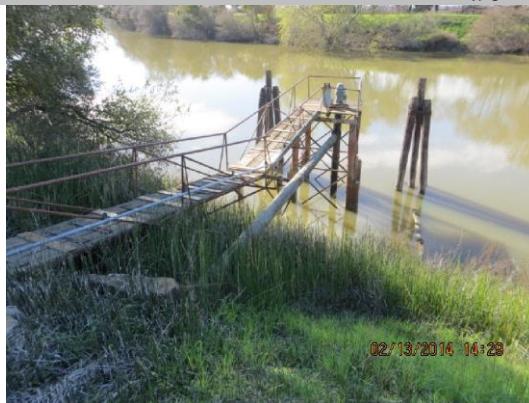
Photo 1 of 3 : UCIP\_SP\_2019\_31287\_57298.jpg

LM Start	1.32	Rating **	M	Issue No.	190	
LM End	1.32	Issue Type +	En	Location *		
Category	Supplemental			GPS Latitude/Longitude		
				Start	End	
Item	DWR UCIP Field Study			38.287515 °	38.287515 °	
				-121.582925 °	-121.582925 °	
DWR ID	24838					
Comment Code						
Inspector Comment						
FS_ID:31287 DS_ID:24838 EP_NO: N/A Repair Type: Non-Urgent Crossing Status: Found UCIP Comments: Appears abandoned and if so should be done so properly. FIELD_STRUCT_DESC: *ABANDONED* 2.5-inch galvanized iron irrigation pipe through the levee, 4 feet below the crown. 1.25-inch galvanized iron electrical conduit at the same location. FS Date: 2/13/2014

Walkway to pier on WS shoulder.

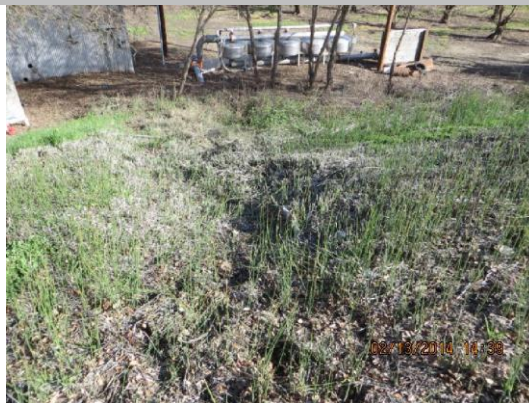
Photo 2 of 3 : UCIP\_SP\_2019\_31287\_57297.jpg

Pipe visible just off LS shoulder in vegetation.

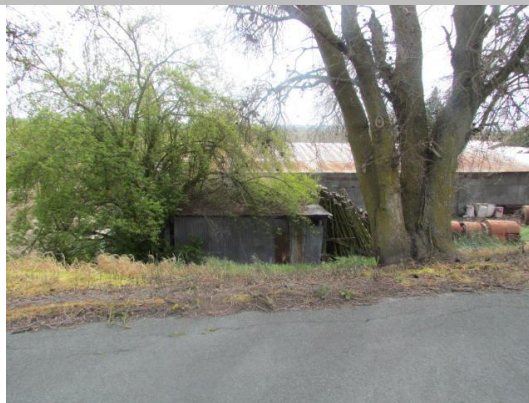
Photo 1 of 3 : SP\_2019\_RD0003\_24\_33\_20190311\_00023.jpg

LM Start	<b>1.39</b>	Rating **	U	Issue No.	<b>33 (cont)</b>
LM End	<b>1.43</b>	Issue Type +	En	Location *	LS

Looking east at tool shed and equipment on landside toe.

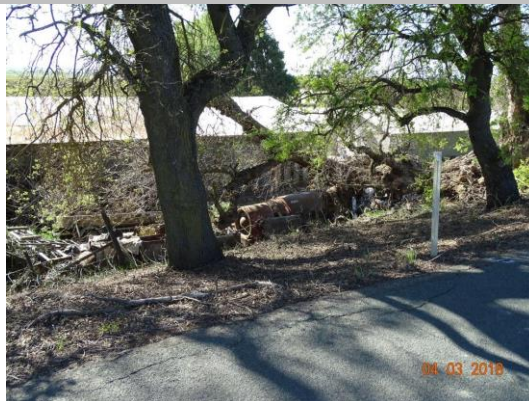
Photo 3 of 3 : SP\_2019\_RD0003\_24\_33\_20190311\_00025.jpg

LM Start	<b>1.39</b>	Rating **	U	Issue No.	<b>33 (cont)</b>
LM End	<b>1.43</b>	Issue Type +	En	Location *	LS

Equipment and fallen tree on landside toe.

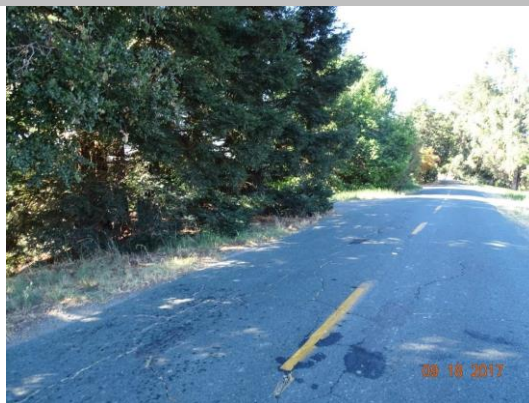
Photo 1 of 2 : SP\_2019\_RD0003\_24\_15\_20190311\_00014.jpg

LM Start	1.59	Rating **	U	Issue No.	15
LM End	1.59	Issue Type +	En	Location *	LS
Category	Earthen Levee			GPS Latitude/Longitude	
				Start	End
Item	Vegetation			38.284777 °	38.284777 °
				-121.586340 °	-121.586340 °
DWR ID	DWR_RD0003_01_f_2018_15				
Comment Code					
V6 : Landscaping					
Inspector Comment					
Large redwood trees are on the landward shoulder.

Looking southwest at landside slope.

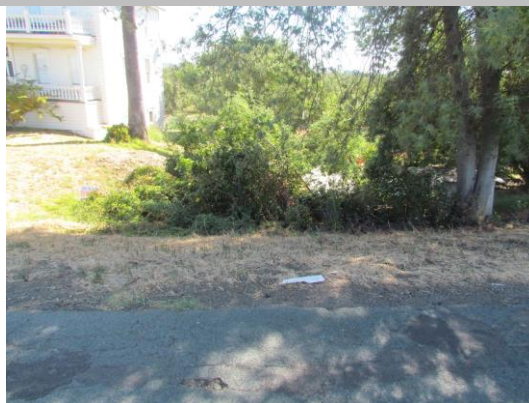
Photo 1 of 2 : SP\_2019\_RD0003\_24\_8\_20190311\_00007.jpg

LM Start	1.76	Rating **	M	Issue No.	8
LM End	1.76	Issue Type +	En	Location *	LS
Category	Earthen Levee			GPS Latitude/Longitude	
				Start	End
Item	Vegetation			38.282771 °	38.282771 °
				-121.588227 °	-121.588227 °
DWR ID	DWR_RD0003_01_s_2012_8				
Comment Code					
V6 : Landscaping					
Inspector Comment

Looking east at vegetation on landward slope. (Fall 2016)

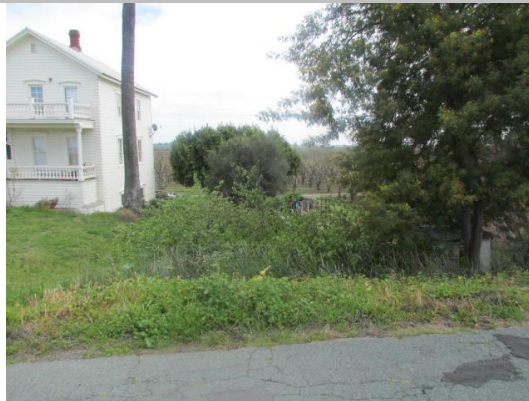
Photo 2 of 2 : SP\_2019\_RD0003\_24\_8\_20190311\_00008.jpg

LM Start	<b>1.76</b>	Rating **	M	Issue No.	<b>8 (cont)</b>
LM End	<b>1.76</b>	Issue Type +	En	Location *	LS

Looking east at vegetation on landside slope.

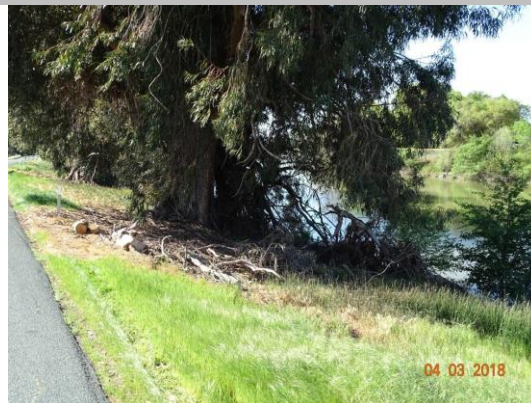
Photo 1 of 1 : SP\_2019\_RD0003\_24\_54\_20190311\_00039.jpg

LM Start	1.91	Rating **	M	Issue No.	54
LM End	1.91	Issue Type +	Ma	Location *	WS
Category	Earthen Levee			GPS Latitude/Longitude	
				Start	End
Item	Encroachments			38.280638 °	38.280638 °
				-121.588457 °	-121.588457 °
DWR ID	DWR_RD0003_01_s_2018_54				
Comment Code					
TR : Tree or limb					
Inspector Comment					
Remove tree trimmings from the waterside slope.

Cut branches on waterside slope.

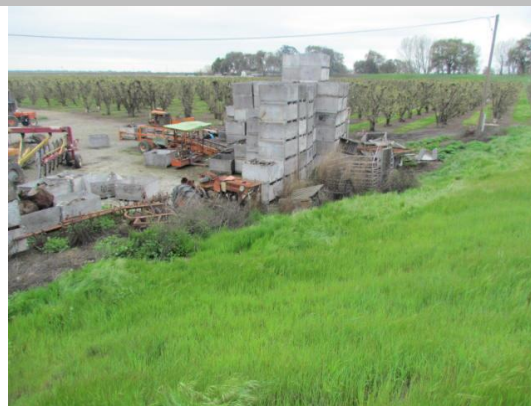
Photo 1 of 1 : SP\_2019\_RD0003\_24\_70\_20190311\_00058.jpg

LM Start	2.11	Rating **	M	Issue No.	70
LM End	2.11	Issue Type +	En	Location *	LS
Category	Earthen Levee			GPS Latitude/Longitude	
				Start	End
Item	Encroachments			38.277908 °	38.277908 °
				-121.589138 °	-121.589138 °
DWR ID	DWR_RD0003_01_s_2016_70				
Comment Code					
EQ : Equipment					
Inspector Comment					
Old farm equipment and storage containers are stored at the landward toe.

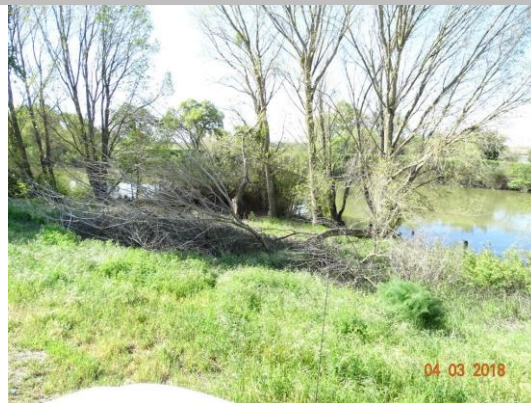
Photo 1 of 1 : SP\_2019\_RD0003\_24\_55\_20190311\_00040.jpg

LM Start	2.27	Rating **	M	Issue No.	55
LM End	2.27	Issue Type +	Ma	Location *	WS
Category	Earthen Levee			GPS Latitude/Longitude	
				Start	End
Item	Encroachments			38.275827 °	38.275827 °
				-121.589979 °	-121.589979 °
DWR ID	DWR_RD0003_01_s_2018_55				
Comment Code					
TR : Tree or limb					
Inspector Comment					
There is a fallen tree on the waterside slope.

Fallen tree limb on waterside.

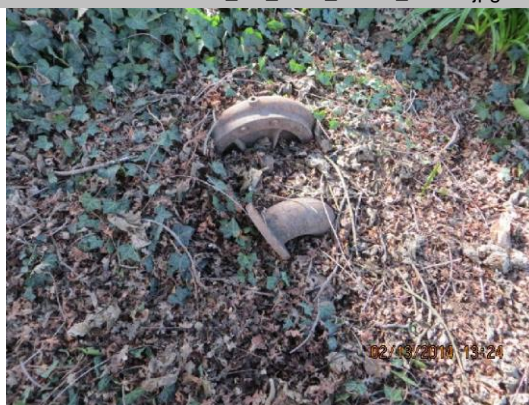
Photo 1 of 3 : UCIP\_SP\_2019\_29569\_54641.jpg

LM Start	2.40	Rating **	M	Issue No.	191
LM End	2.40	Issue Type +	En	Location *	
Category	Supplemental			GPS Latitude/Longitude	
				Start	End
Item	DWR UCIP Field Study			38.274633 °	38.274633 °
				-121.588121 °	-121.588121 °
DWR ID	22324				
Comment Code					
Inspector Comment					
FS_ID:29569 DS_ID:22324 EP_NO: 4346 Repair Type: Non-Urgent Crossing Status: Indicator Found UCIP Comments: Pipe is abandoned and should be verified as having been done so properly. FIELD_STRUCT_DESC: 6-inch steel irrigation discharge pipe through the levee, invert elevation 1.5 feet below the crown. Pump visible at the landside (LS) toe. (Plans for replacing existing 10-inch pipe with a new 10-inch pipe through the levee authorized under Permit No. 4346, 1963 - Hamatani Brothers). [Additional Reference(s): USACE Sacramento O&M Manual 104, February 1960, (RM 23.70)]. FS Date: 2/13/2014

Pump visible on LS toe.

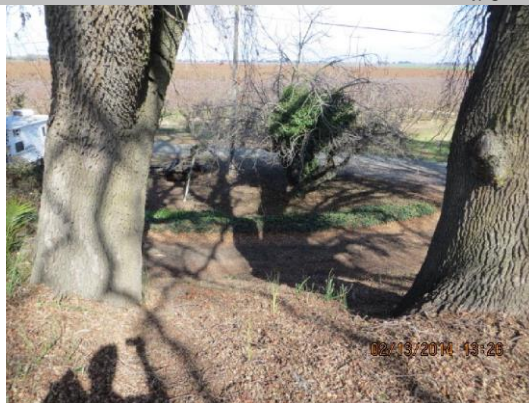
Photo 2 of 3 : UCIP\_SP\_2019\_29569\_54640.jpg

LM Start	2.40	Rating **	M	Issue No.	191 (cont)	
LM End	2.40	Issue Type +	En	Location *		
Category	Supplemental			GPS Latitude/Longitude		
				Start		End
Item	DWR UCIP Field Study			38.274633 °		38.274633 °
				-121.588121 °		-121.588121 °
DWR ID	22324					
Comment Code						
Inspector Comment						
FS_ID:29569 DS_ID:22324 EP_NO: 4346 Repair Type: Non-Urgent Crossing Status: Indicator Found UCIP Comments: Pipe is abandoned and should be verified as having been done so properly. FIELD_STRUCT_DESC: 6-inch steel irrigation discharge pipe through the levee, invert elevation 1.5 feet below the crown. Pump visible at the landside (LS) toe. (Plans for replacing existing 10-inch pipe with a new 10-inch pipe through the levee authorized under Permit No. 4346, 1963 - Hamatani Brothers). [Additional Reference(s): USACE Sacramento O&M Manual 104, February 1960, (RM 23.70)]. FS Date: 2/13/2014

Pump visible at LS toe. Pipe alignment of old pipe goes between two large oaks on LS shoulder.

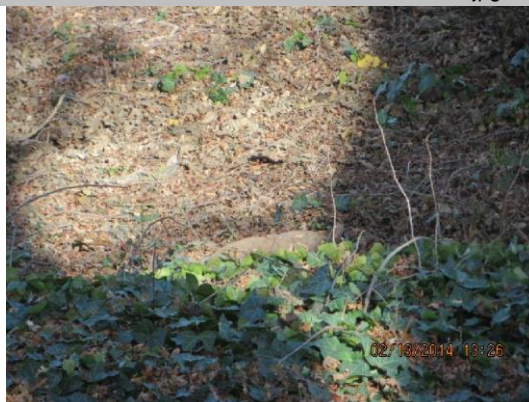
Photo 3 of 3 : UCIP\_SP\_2019\_29569\_54639.jpg

Pump visible on LS toe.

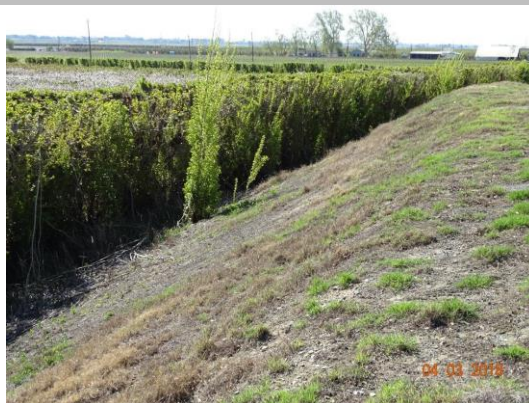
Photo 1 of 1 : SP\_2019\_RD0003\_24\_57\_20190311\_00043.jpg

LM Start	2.43	Rating **	U	Issue No.	57
LM End	2.74	Issue Type +	En	Location *	LS
Category	Earthen Levee			GPS Latitude/Longitude	
				Start	End
Item	Encroachments			38.274213 °	38.269914 °
				-121.587646 °	-121.588682 °
DWR ID	DWR_RD0003_01_s_2018_57				
Comment Code					
TR : Tree or limb					
Inspector Comment					
A row of trees along the toe of levee inhibits inspection and prevents access.

Closely spaced trees along toe.

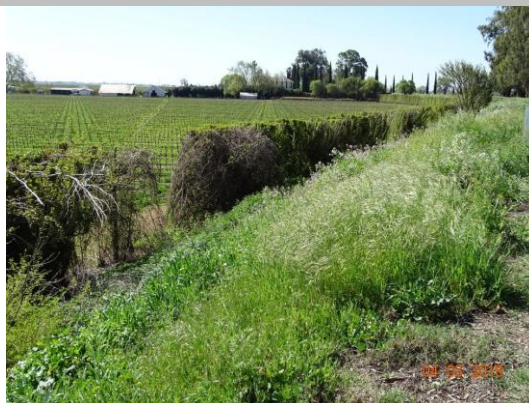
Photo 1 of 1 : SP\_2019\_RD0003\_24\_65\_20190311\_00054.jpg

LM Start	2.53	Rating **	U	Issue No.	65
LM End	2.57	Issue Type +	Ma	Location *	LS
Category	Earthen Levee			GPS Latitude/Longitude	
				Start	End
Item	Vegetation			38.272886 °	38.272262 °
				-121.587624 °	-121.588010 °
DWR ID	DWR_RD0003_01_s_2018_65				
Comment Code					
V1 : Control annual grass and weeds on the levee slopes and easements.					
Inspector Comment

Landside vegetation.

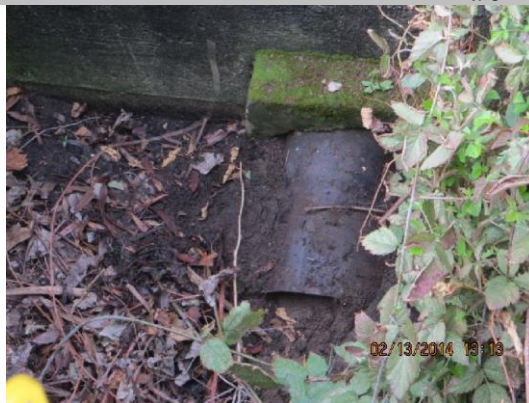
Photo 1 of 2 : UCIP\_SP\_2019\_29567\_54634.jpg

LM Start	2.55	Rating **	M	Issue No.	192
LM End	2.55	Issue Type +	En	Location *	
Category	Supplemental			GPS Latitude/Longitude	
				Start	End
Item	DWR UCIP Field Study			38.272613 °	38.272613 °
				-121.587821 °	-121.587821 °
DWR ID	22146				
Comment Code					
Inspector Comment					
FS_ID:29567 DS_ID:22146 EP_NO: N/A Repair Type: Non-Urgent Crossing Status: Found UCIP Comments: Need to verify proper abandonment of irrigation pipe. FIELD_STRUCT_DESC: *ABANDONED* 10-inch steel irrigation discharge pipe through the levee, invert elevation 4.2 feet below the crown. 5-foot by 7-foot concrete distribution box at the landside (LS) toe. Cannot see pipe on the waterside (WS). [Additional Reference(s): DWR Levee Log, 1993. USACE Sacramento O&M Manual 104, February 1960, (RM 23.55)]. FS Date: 2/13/2014

Pipe visible inside concrete distribution box on LS toe.

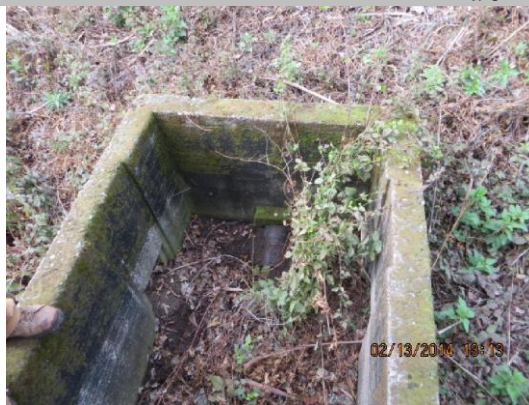
Photo 2 of 2 : UCIP\_SP\_2019\_29567\_54633.jpg

Pipe visible inside concrete distribution box on LS toe.

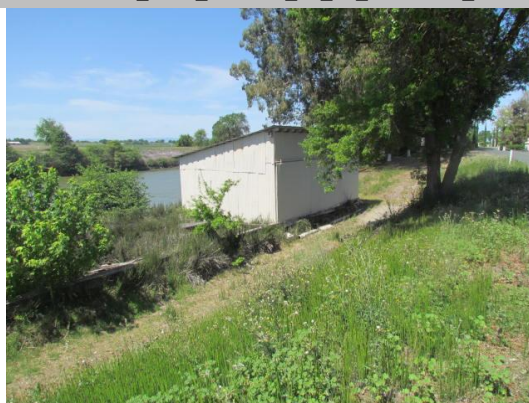
Photo 1 of 1 : SP\_2019\_RD0003\_24\_48\_20190311\_00029.jpg

LM Start	2.87	Rating **	U	Issue No.	48
LM End	2.87	Issue Type +	En	Location *	WS
Category	Earthen Levee			GPS Latitude/Longitude	
				Start	End
Item	Encroachments			38.268257 °	38.268257 °
				-121.587677 °	-121.587677 °
DWR ID	DWR_RD0003_01_s_2013_48				
Comment Code					
BU : Building					
Inspector Comment					
A storage shed has been located here for several years on the waterward berm. The storage shed appears to be abandoned and should be removed.

Looking northwest at storage shed on waterward berm.

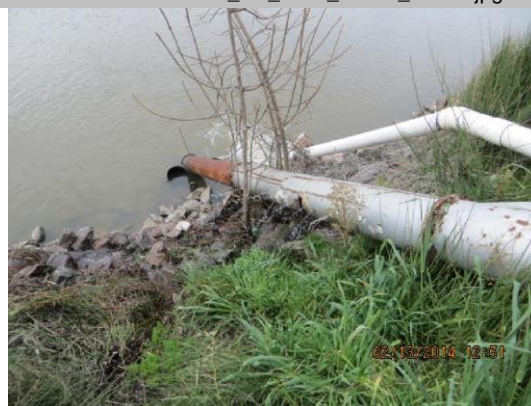
Photo 1 of 3 : UCIP\_SP\_2019\_29563\_54622.jpg

Comment Code					
Inspector Comment					
FS_ID:29563 DS_ID:22148 EP_NO: N/A Repair Type: Non-Urgent Crossing Status: Found UCIP Comments: Pitted holes on slant pump intake may indicate internal problem. Good candidate for video inspection. FIELD_STRUCT_DESC: 14-inch steel irrigation discharge pipe though the levee, invert elevation 6.3 feet below the crown. Service pole on the landside (LS) slope. 1.5-inch electrical conduit through the levee to the pump on the waterside (WS). 36-inch concrete standpipe at the landside (LS) toe. [Additional Reference(s): DWR Levee Log, 1993, 16-inch pipe referenced. USACE Sacramento O&M Manual 104, February 1960, (RM 23.17), 16-inch pipe referenced]. FS Date: 2/13/2014

Intake pipe at slantpump on WS slope.

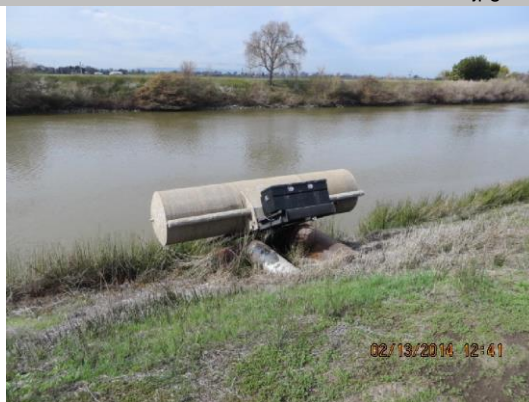
Photo 2 of 2 : UCIP\_SP\_2019\_31327\_57379.jpg

Pipe with fish screen visible on WS slope.

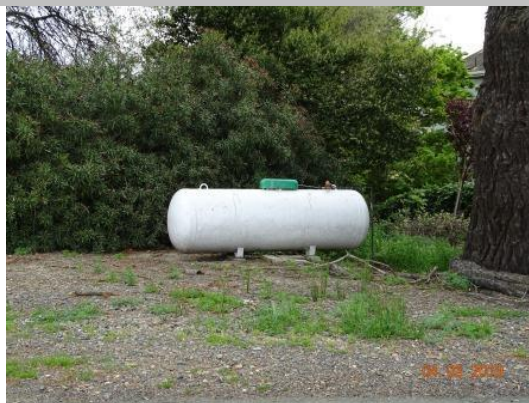
Photo 1 of 1 : SP\_2019\_RD0003\_24\_110\_20190403\_00172.jpg

LM Start	3.12	Rating **	M	Issue No.	110
LM End	3.12	Issue Type +	En	Location *	LS
Category	Earthen Levee			GPS Latitude/Longitude	
				Start	End
Item	Encroachments			38.264688 °	38.264688 °
				-121.587159 °	-121.587159 °
DWR ID	DWR_RD0003_01_s_2019_110				
Comment Code					
TA : Tank					
Inspector Comment					
There is a tank on the landside slope.

View of tank on the landside slope (Spring 2019).

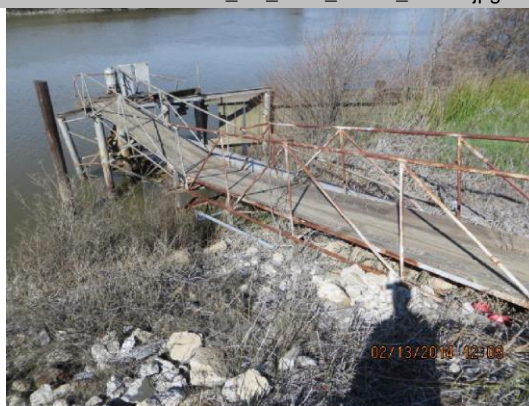
Photo 1 of 3 : UCIP\_SP\_2019\_29547\_54611.jpg

Comment Code					
Inspector Comment					
FS_ID:29547 DS_ID:22151 EP_NO: 1113 Repair Type: Non-Urgent Crossing Status: Found UCIP Comments: Pump pier is damaged and falling into the water. FIELD_STRUCT_DESC: 12-inch steel irrigation discharge pipe through the levee, invert elevation 4 feet below the crown. Vertical pump on a pile structure in the stream. Walkway from the waterside (WS) berm to the pump. 1.5-inch electrical conduit and 2.5-inch filler pipe at the same location. 36-inch concrete standpipe on the landside (LS) toe. (Plans for the installation of a 12-inch irrigation pipe through the levee authorized under Permit No. 1113, 1946 - Elsie Goldman Dixon). [Additional Reference(s): DWR Levee Log, 1993. USACE Sacramento O&M Manual 104, February 1960, (RM 22.85)]. FS Date: 2/13/2014

Walkway to pump on pier at WS slope.

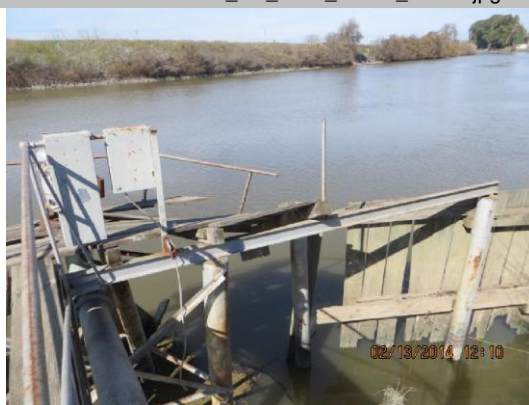
Photo 2 of 3 : UCIP\_SP\_2019\_29547\_54610.jpg

Damaged pump platform at WS toe.

Comment Code						
Inspector Comment						
FS_ID:29547 DS_ID:22151 EP_NO: 1113 Repair Type: Non-Urgent Crossing Status: Found UCIP Comments: Pump pier is damaged and falling into the water. FIELD_STRUCT_DESC: 12-inch steel irrigation discharge pipe through the levee, invert elevation 4 feet below the crown. Vertical pump on a pile structure in the stream. Walkway from the waterside (WS) berm to the pump. 1.5-inch electrical conduit and 2.5-inch filler pipe at the same location. 36-inch concrete standpipe on the landside (LS) toe. (Plans for the installation of a 12-inch irrigation pipe through the levee authorized under Permit No. 1113, 1946 - Elsie Goldman Dixon). [Additional Reference(s): DWR Levee Log, 1993. USACE Sacramento O&M Manual 104, February 1960, (RM 22.85)]. FS Date: 2/13/2014

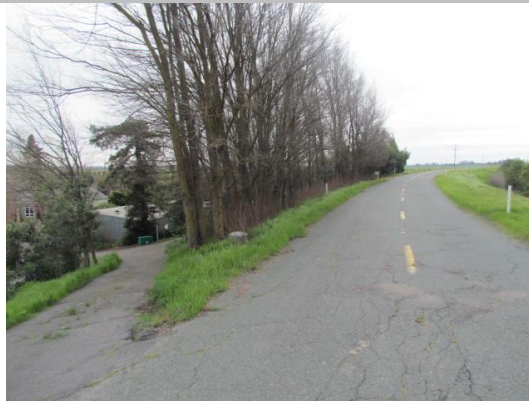
Photo 2 of 3 : SP\_2019\_RD0003\_24\_9\_20190311\_00010.jpg

Looking south at trees on landward shoulder and slope (Spring 2016).

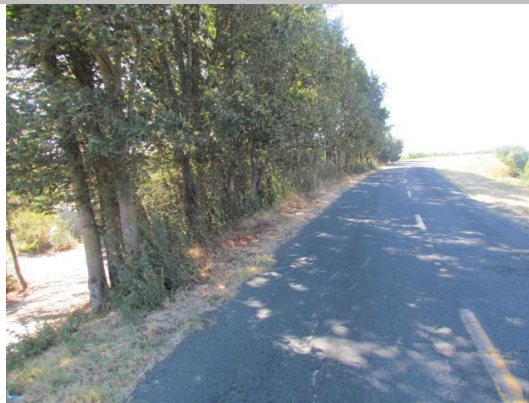
Photo 3 of 3 : SP\_2019\_RD0003\_24\_9\_20190311\_00011.jpg

Looking south at trees on landward shoulder and slope. (Fall 2015)

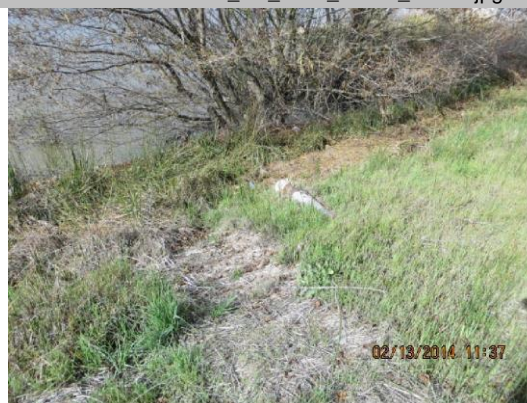
Photo 1 of 3 : UCIP\_SP\_2019\_29530\_54592.jpg

Comment Code					
Inspector Comment					
FS_ID:29530 DS_ID:22317 EP_NO: 17221 Repair Type: Non-Urgent Crossing Status: Found UCIP Comments: Open trench along WS slope paralell to river. FIELD_STRUCT_DESC: 7-inch steel boat dock service conduit through the levee, 4 feet below the crown. 1.5-inch and 4-inch polyvinyl chloride (PVC) pipes sleeved through the 7-inch conduit. Steps on the waterside (WS) slope. Tank on the landside (LS) shoulder. Conduit provides service to the boat dock just upstream. (Plans to install 1.5-inch and 4-inch PVC pipes through the existing 8-inch steel pipe and through the LS slope, to construct a 48-foot by 21-foot boat dock supported on four steel piles, and to construct a 14-foot-wide access ramp on the LS slope authorized under Permit No. 17221, 2000 - Hart, Inc). FS Date: 2/13/2014

7-inch pipe visible on WS slope.

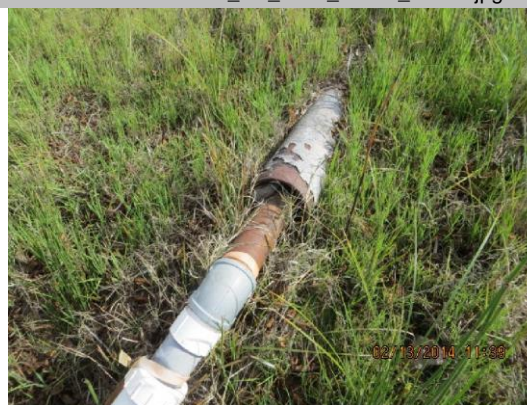
Photo 2 of 3 : UCIP\_SP\_2019\_29530\_54591.jpg

Conduits running through pipe on WS slope.

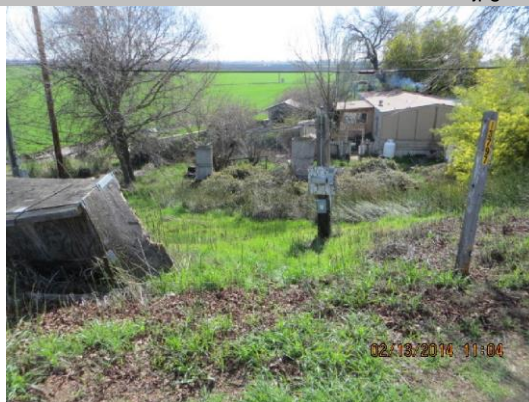
Photo 2 of 3 : UCIP\_SP\_2019\_31584\_57842.jpg

Pump and tank in box on LS shoulder with concrete standpipe visible on LS toe.

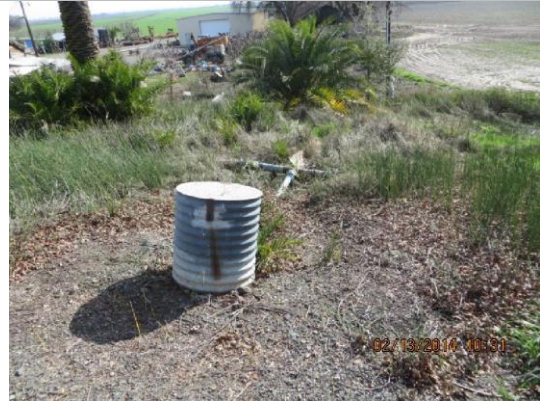
Photo 2 of 3 : UCIP\_SP\_2019\_53483\_54545.jpg

Comment Code						
Inspector Comment						
FS_ID:53483 DS_ID:22163 EP_NO: N/A Repair Type: Urgent Crossing Status: Found UCIP Comments: 07/20/2018 Everything appears to be the same as last time. No changes have been made. Most of the pipe still remains. Did not see any active leakage. Tape was wrapped around the pipe connections on the LS in 2016 to prevent leaking. Crossing remains "Urgent" due to the pipe integrity issues that have not been fully addressed. (DWR UCIP - A. McDonald)09/29/2017 Received updated photo from DWR levee inspector, D. Torres, and photo shows part or all of the pipe has been removed. Inspector could not verify proper abandonment. Need to coordinate with LMA and owner to determine supporting documentation to support the work completed at this site. This crossing remains urgent due to the details of the extent of the removal. No permit was found to authorizing levee work. (DWR UCIP - O. Magana) 07/06/2016 Pipe diversion off main steam on LS has tape wrapped around its connections, a possible attempt to contain past leakage. Did not see active leakage. Slight sloughing on LS slope at diversion manifold. (DWR UCIP - kfazel)02/13/2014 Pipe disconnected or diverted on LS shoulder and leaking. Water runs down LS slope freely causing erosion. Siphon breaker not visible in CMP riser. Walkway to pump in poor structural condition. (DWR UCIP - pamatya) FIELD_STRUCT_DESC: *ABANDONED* 10-inch steel irrigation discharge pipe through the levee, 4 feet below the crown. Siphon breaker in a corrugated metal pipe (CMP) riser on the landside (LS) shoulder. Slant pump on a pile structure in the stream. Pipe exposed on the waterside (WS) berm. 36-inch concrete standpipe off the LS toe. 1.5-inch electrical conduit of an unknown material through the levee, 2 feet below the crown, at the same location. (Charlotte K. Hales). [Additional Reference(s): DWR Levee Log, 1993]. FS Date: 7/20/2018

24-inch CMP riser for siphon breaker on LS shoulder.

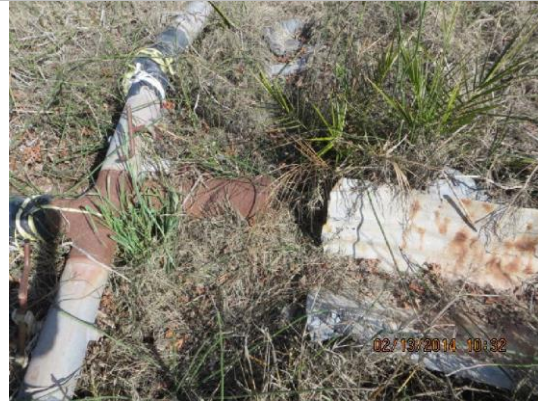
Photo 3 of 3 : UCIP\_SP\_2019\_53483\_54544.jpg

Pipe diversion manifold just below siphon breaker on LS slope. Tin diverts water downslope.

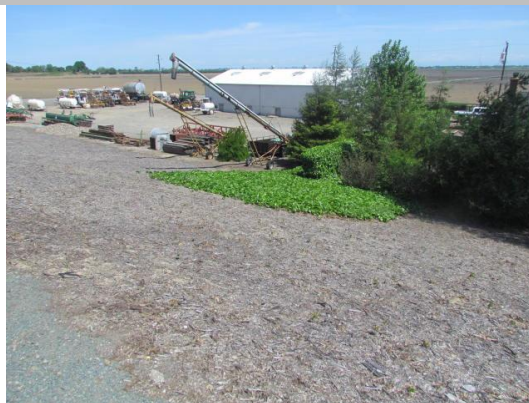
Photo 1 of 1 : SP\_2019\_RD0003\_24\_50\_20190311\_00031.jpg

LM Start	4.76	Rating **	M	Issue No.	50
LM End	4.76	Issue Type +	En	Location *	LS
Category	Earthen Levee			GPS Latitude/Longitude	
				Start	End
Item	Vegetation			38.247563 °	38.247563 °
				-121.600865 °	-121.600865 °
DWR ID	DWR_RD0003_01_s_2013_50				
Comment Code					
V6 : Landscaping					
Inspector Comment					
Ivy is covering the lower half of the landward slope and toe.

Looking northeast at landscaping at lower half of landward slope and toe.

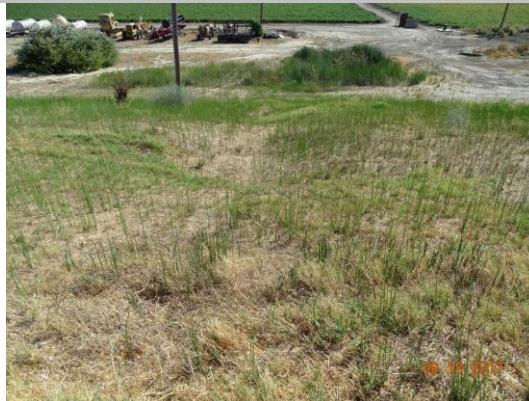
Photo 1 of 1 : SP\_2019\_RD0003\_24\_83\_20190311\_00076.jpg

LM Start	4.87	Rating **	M	Issue No.	83
LM End	4.87	Issue Type +	Ma	Location *	LS
Category	Earthen Levee			GPS Latitude/Longitude	
				Start	End
Item	Slope Stability			38.245903 °	38.245903 °
				-121.600851 °	-121.600851 °
DWR ID	DWR_RD0003_01_f_2017_83				
Comment Code					
S1 : Repair slope instability.					
Inspector Comment					
The landside slope has a depression.

Looking east on landside slope.

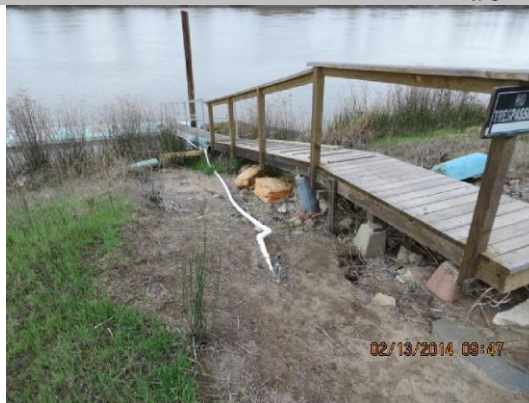
Photo 1 of 3 : UCIP\_SP\_2019\_31286\_57295.jpg

LM Start	5.10	Rating **	M	Issue No.	200
LM End	5.10	Issue Type +	En	Location *	
Category	Supplemental			GPS Latitude/Longitude	
				Start	End
Item	DWR UCIP Field Study			38.242649 °	38.242649 °
				-121.600854 °	-121.600854 °
DWR ID	24837				
Comment Code					
Inspector Comment					
FS_ID:31286 DS_ID:24837 EP_NO: N/A Repair Type: Non-Urgent Crossing Status: Found UCIP Comments: No permit identified for this crossing. FIELD_STRUCT_DESC: 1.5-inch polyvinyl chloride (PVC) irrigation pipe through the levee, 2 feet below the crown. Pump at the landside (LS) toe. Vent on the waterside (WS) shoulder. This crossing was field discovered. FS Date: 2/13/2014

Pipe and vent visible next to wooden walkway on WS shoulder.

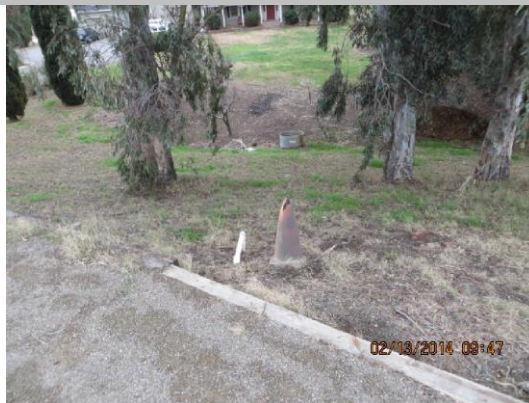
Photo 2 of 3 : UCIP\_SP\_2019\_31286\_57294.jpg

Pipe visible on LS shoulder with pump visible at LS toe in background.

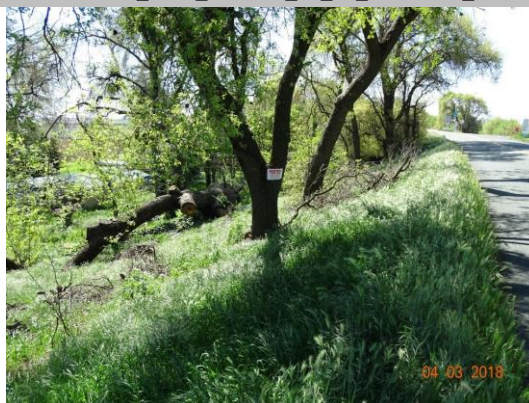
Photo 1 of 1 : SP\_2019\_RD0003\_24\_58\_20190311\_00044.jpg

LM Start	5.46	Rating **	U	Issue No.	58
LM End	5.46	Issue Type +	En	Location *	LS
Category	Earthen Levee			GPS Latitude/Longitude	
				Start	End
Item	Encroachments			38.237515 °	38.237515 °
				-121.602225 °	-121.602225 °
DWR ID	DWR_RD0003_01_s_2017_58				
Comment Code					
TR : Tree or limb					
Inspector Comment					
A downed tree with large root ball on the landward slope is being cut up and should be removed.

Removal of large fallen tree should continue.

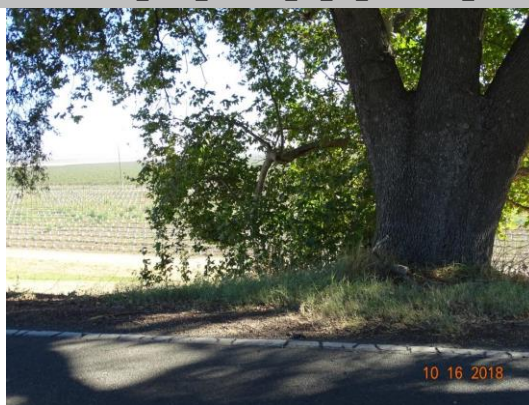
Photo 1 of 2 : SP\_2019\_RD0003\_24\_63\_20190311\_00051.jpg

LM Start	5.65	Rating **	M	Issue No.	63
LM End	5.65	Issue Type +	Ma	Location *	LS
Category	Earthen Levee			GPS Latitude/Longitude	
				Start	End
Item	Trim / Thin Trees			38.234721 °	38.234721 °
				-121.601709 °	-121.601709 °
DWR ID	DWR_RD0003_01_f_2016_63				
Comment Code					
T1 : Trim trees to at least five feet above ground level.					
Inspector Comment					
Trim the growth from the tree so that the levee slope can be seen.

View of slope where tree limb was removed. Now the extra growth on the existing branches needs to be removed (October 2018).

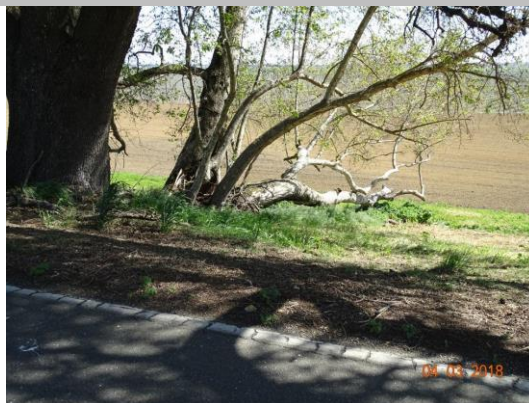
Photo 2 of 2 : SP\_2019\_RD0003\_24\_63\_20190311\_00052.jpg

Low-lying tree limb should be removed from landside slope.

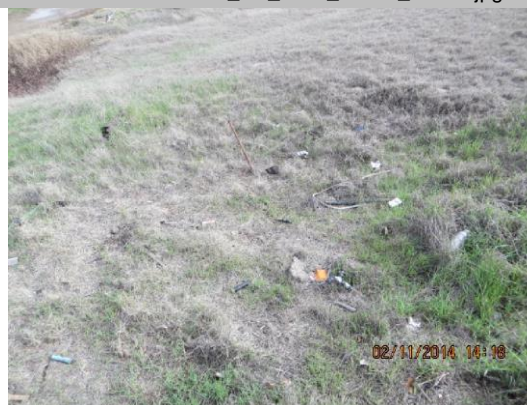
Photo 1 of 3 : UCIP\_SP\_2019\_29823\_55105.jpg

LM Start	5.94	Rating **	M	Issue No.	201
LM End	5.94	Issue Type +	En	Location *	
Category	Supplemental			GPS Latitude/Longitude	
				Start	End
Item	DWR UCIP Field Study			38.230620 °	38.230620 °
				-121.601588 °	-121.601588 °
DWR ID	22171				
Comment Code					
Inspector Comment					
FS_ID:29823 DS_ID:22171 EP_NO: N/A Repair Type: Non-Urgent Crossing Status: Found UCIP Comments: Pipe appears abandoned or in disrepair at siphon/vent on LS shoulder. FIELD_STRUCT_DESC: 12-inch steel irrigation siphon through the levee, invert elevation 4 feet below the crown. Pipe discharges into a large hole at the landside (LS) toe which is connected to irrigation ditches. Siphon and vent visible on the landside (LS) shoulder. (USACE Unit No. 10, new pipe in 1966 - W. Beck). [Additional Reference(s): DWR Levee Log, 1993. USACE Sacramento O&M Manual 104, February 1960, (RM 20.13)]. FS Date: 2/11/2014

Siphon and vent on LS shoulder.

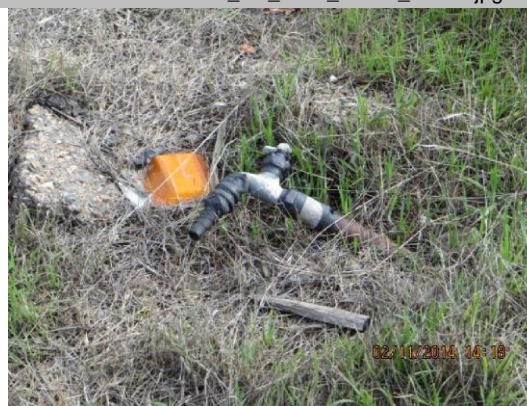
Photo 2 of 3 : UCIP\_SP\_2019\_29823\_55104.jpg

Comment Code						
Inspector Comment						
FS_ID:29823						
DS_ID:22171						
EP_NO: N/A						
Repair Type: Non-Urgent						
Crossing Status: Found						
UCIP Comments: Pipe appears abandoned or in disrepair at siphon/vent on LS shoulder.						
FIELD_STRUCT_DESC: 12-inch steel irrigation siphon through the levee, invert elevation 4 feet below the crown. Pipe discharges into a large hole at the landside (LS) toe which is connected to irrigation ditches. Siphon and vent visible on the landside (LS) shoulder. (USACE Unit No. 10, new pipe in 1966 - W. Beck). [Additional Reference(s): DWR Levee Log, 1993. USACE Sacramento O&M Manual 104, February 1960, (RM 20.13)].						
FS Date: 2/11/2014

Vent on LS shoulder.

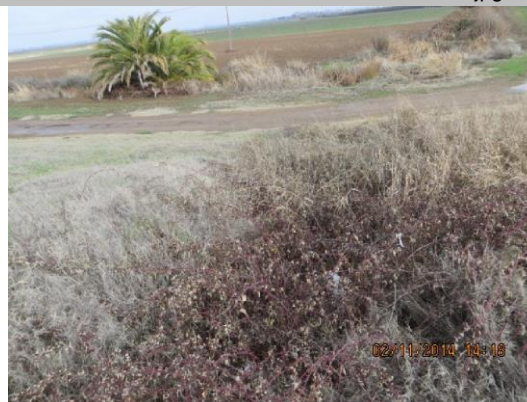
Photo 3 of 3 : UCIP\_SP\_2019\_29823\_55103.jpg

Irrigation ditch filled with berries on LS toe.

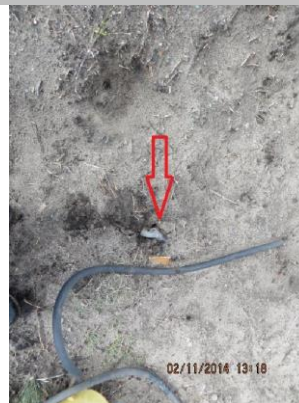
Photo 3 of 3 : UCIP\_SP\_2019\_29258\_54136.jpg

Comment Code						
Inspector Comment						
FS_ID:29258 DS_ID:22179 EP_NO: 853 Repair Type: Non-Urgent Crossing Status: Found UCIP Comments: Siphon breaker/vent needs proper installation/riser. FIELD_STRUCT_DESC: 12-inch steel irrigation siphon through the levee, invert elevation 4 feet below the crown. Siphon breaker on the landside (LS) shoulder. 36-inch concrete standpipe on the LS toe. (Plans for the installation of a 6-inch horizontal bolted centrifugal pump together with an 8-inch, 10-gauge welded steel pipe through the levee authorized under Permit No. 853, 1941 - Louis A. Bixler. Plans for installing a 12-inch steel irrigation siphon through the levee authorized under Permit No. 1462, 1950 - Vic Romanini. USACE Unit No. 10, new pipe installed in 1967). [Additional Reference(s): DWR Levee Log, 1993. USACE Sacramento O&M Manual 104, February 1960, (RM 19.20)]. FS Date: 2/11/2014

Siphon breaker/vent visible on LS slope.

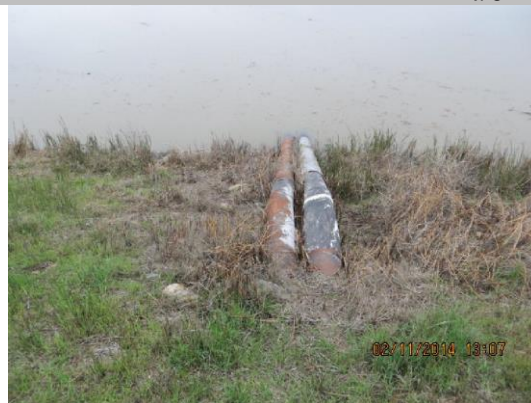
Photo 1 of 3 : UCIP\_SP\_2019\_50428\_54124.jpg

FS\_ID:50428  
DS\_ID:22346  
EP\_NO: N/A  
Repair Type: Non-Urgent  
Crossing Status: Found  
UCIP Comments: 07/06/2016 Same as last inspection. Annular space needs to be grouted per Title 23. This crossing has been downgraded from Urgent to Non-Urgent because the hole created in the conduit sleeve was deliberate and not a sign of pipe failure. Pipe was flowing at the time of the inspection (possibly via a portable pump). (DWR UCIP - K. Fazel)02/11/2014 Pipe cut open on LS shoulder and along slope. 3.5-inch PVC pipe sleeved through with 2 vents with valves. Pipe annular space not grouted. (DWR FPIIB - G. Wylie)  
FIELD\_STRUCT\_DESC: 1 of 2: 12-inch steel irrigation siphon through the levee, invert elevation 3 feet below the crown. Siphon breaker on the landside (LS) shoulder. 3.5-inch polyvinyl chloride (PVC) pipe sleeved through the existing 12-inch pipe. (Vic Romanini). [Additional Reference(s): DWR Levee Log, 1993. USACE Sacramento O&M Manual 104, February 1960, (RM 19.06)].

Steel pipe visible on WS slope

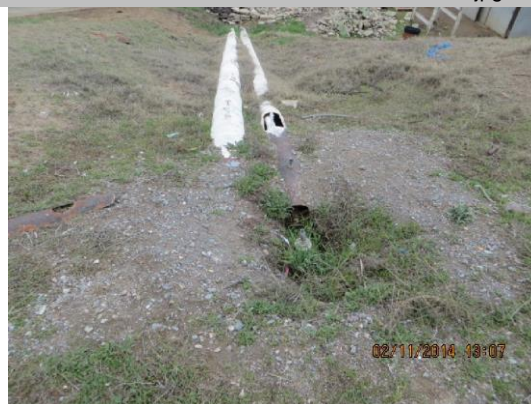
Photo 2 of 3 : UCIP\_SP\_2019\_50428\_54123.jpg

Pipe visible on LS slope with cuts at two places.

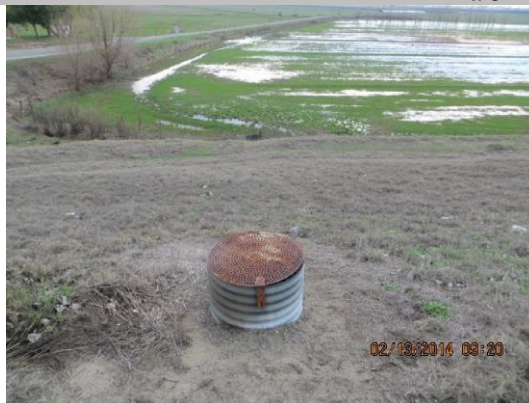
Photo 1 of 2 : UCIP\_SP\_2019\_29924\_55248.jpg

LM Start	7.10	Rating **	M	Issue No.	207
LM End	7.10	Issue Type +	En	Location *	
Category	Supplemental			GPS Latitude/Longitude	
				Start	End
Item	DWR UCIP Field Study			38.214684 °	38.214684 °
				-121.605242 °	-121.605242 °
DWR ID	22181				
Comment Code					
Inspector Comment					
FS_ID:29924 DS_ID:22181 EP_NO: N/A Repair Type: Non-Urgent Crossing Status: Found UCIP Comments: Pipe appears abandoned and should be verified as having been done so properly. FIELD_STRUCT_DESC: 12-inch steel irrigation siphon through the levee, invert elevation 3 feet below the crown. Siphon breaker in a 24-inch corrugated metal pipe (CMP) riser on the landside (LS) shoulder. 4-foot concrete standpipe at the LS toe. (Vic Romanini). [Additional Reference(s): DWR Levee Log, 1993. USACE Sacramento O&M Manual 104, February 1960, (RM 18.89)]. FS Date: 2/11/2014

Siphon breaker in CMP riser on LS shoulder.

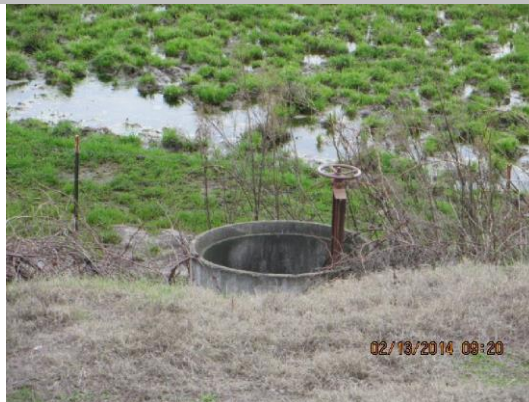
Photo 2 of 2 : UCIP\_SP\_2019\_29924\_55247.jpg

Concrete standpipe on LS toe.
